BRIGHTWATER ROADWAYS and DRAINAGE

JUNE 2013

Prepared by: Alpine Engineering, Inc.
P.O. Box 97
Edwards, CO 81632
(970) 926-3373

Prepared for: Brightwater Club Property Owners
c/o Robertson and Marchetti
28 Second Street, Suite 213
Edwards, CO 81632

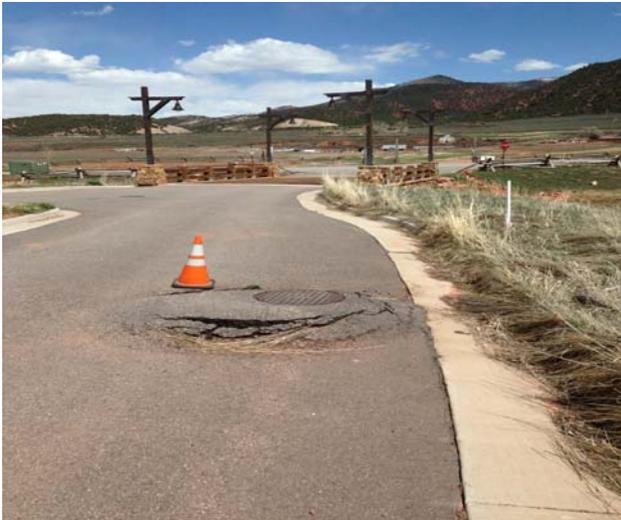
The settlement at the entry is centered around a manhole.

Settlement at entry

The entry settlement is a hazard and in need of repair. The asphalt in this area should be removed and a geotechnical engineer should observe the underlying soils to determine the cause and make repair recommendations. Recommendations might include removal of some of the underlying soils, possible installation of soil reinforcing Geogrid and replacement and compaction of gravel materials and replacement of the asphalt. It also appears the south curb & gutter and adjacent pavement, on both sides of the outbound gate, may have some settlement. A survey of this area may be warranted, to determine the appropriate extent of the roadway repairs in this area.

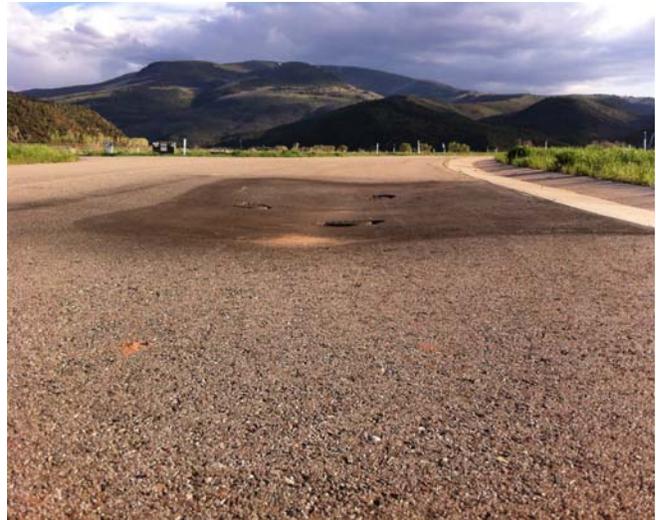
Settlement around waterline valves in Lantern's Way

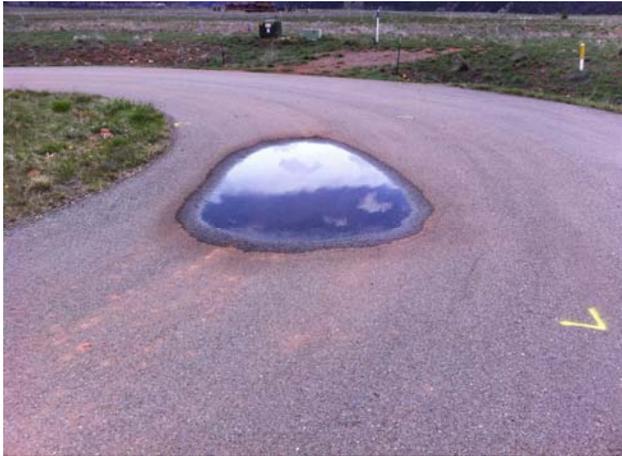
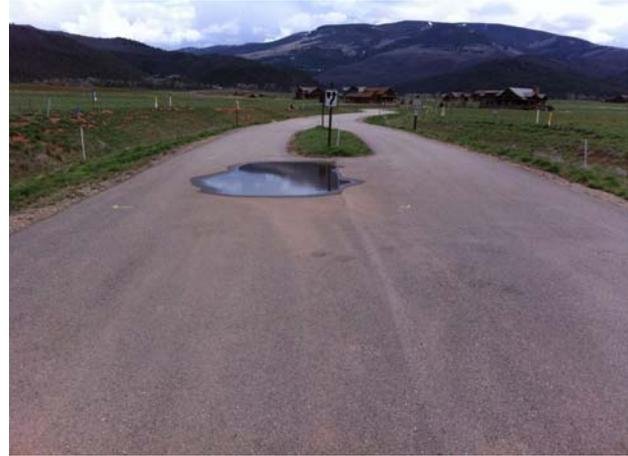
Areas of water ponding on the asphalt (bird baths) were marked with yellow paint by Tim Taagen following a rain storm.

‘Bird baths’ in pavement

There were approximately 29 depressed areas with ponding identified. Pictures of each of these are included at the end of this report. Many of these areas appear to be in the vicinity of manholes, gate valve boxes, and utility trenches. These may be the result of consolidation of backfill materials. When these become large enough to be problematic they should be repaired. Repairs may consist of removing the asphalt in the depressed areas, compaction of subgrade and patching the asphalt. If the underlying soils are poor then they may also require reinforcement and replacement with good gravel materials.

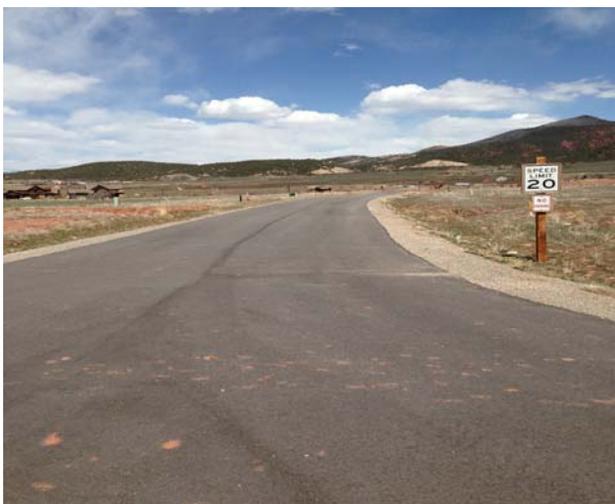
The pavement section appears to have performed well, in that signs of distressed pavement (alligating, rutting, raveling, bleeding, edge damage, oxidation) are not readily apparent. As stated in the “Preliminary Geotechnical Evaluation, Valagua Property Phase 1, Gypsum, Colorado”, ‘performance of the pavement structure is directly related to the physical properties of the subgrade soils and traffic loadings.’ Given the large amount of vacant lots, the pavement has not been subject to significant amounts of construction traffic. When construction traffic increases, additional road maintenance maybe required.

Pavement in good condition

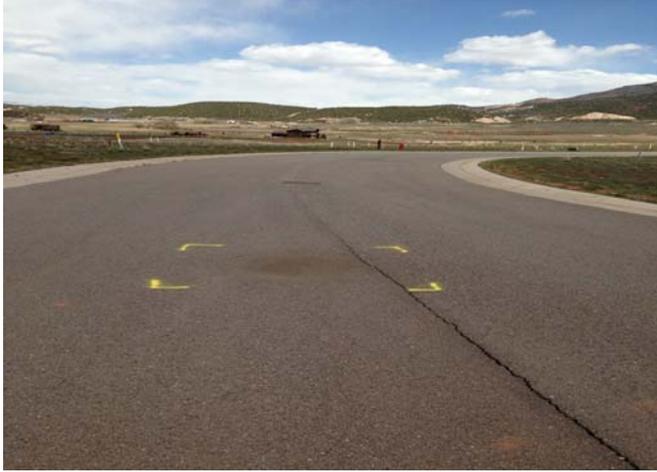
Longitudinal crack in asphalt

There are a few cracks in the asphalt. These do not appear to be widespread but they should be crack sealed to prevent water from going through the crack and weakening the underlying soils.

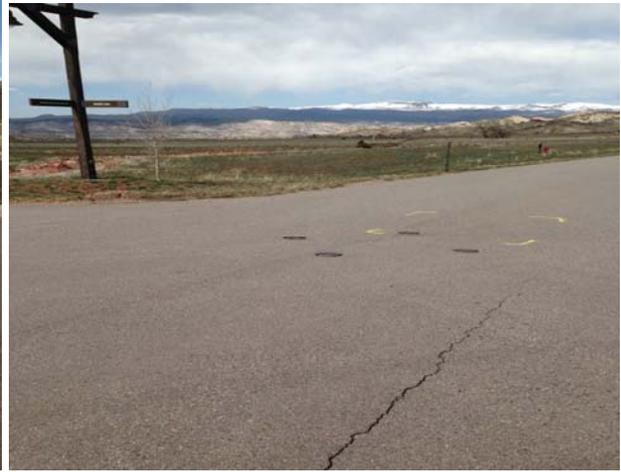
Asphalt crack

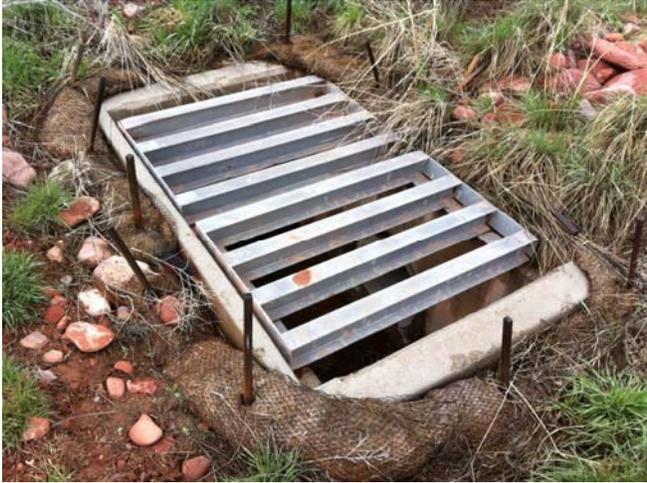
The storm sewer (inlets, manholes and connecting pipes) appeared to be relatively clean and free of sediment. It should be noted that most of the storm sewer piping was inaccessible, however, several of the Type D inlets at the intersection of Brightwater Club Rd & Latigo Trail were entered and the connecting pipes were observed to be clean. There are three Type D inlets at this intersection, with two grates on each inlet and two nuts affixing each grate. Most of these nuts were loose and in one case, missing. The inlet to the south of the intersection also had a substantial amount of dead vegetation (tumble weeds) covering the inlet grates.

Type D inlet.

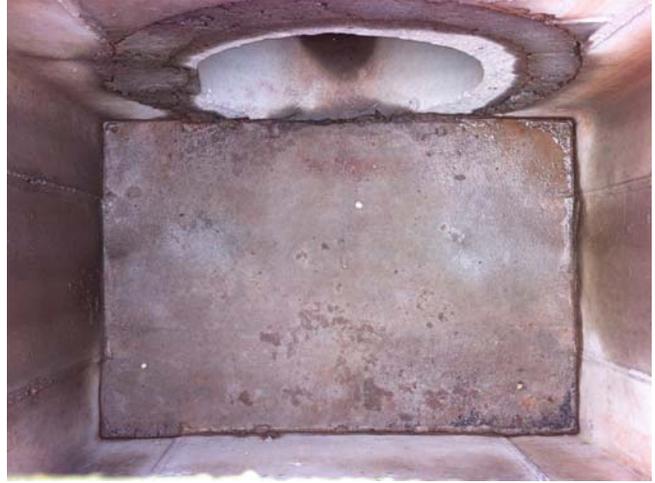
Inlet in Bridal Path.

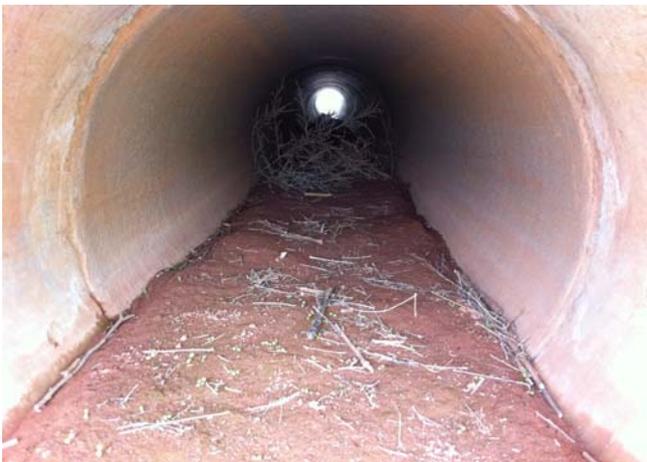
Each of the inlets and storm sewer manholes were looked into and appeared to be in good condition with minimal or no sediment observed. Each of the cross-culverts (drainage pipe crossing under a road with flared end sections) were also observed. Most of these pipes had some sediment, typically 1"-2", in the bottom of the pipe and end sections. Most of the pipes also had dead vegetation at each end section.

Culvert under Foxprowl.

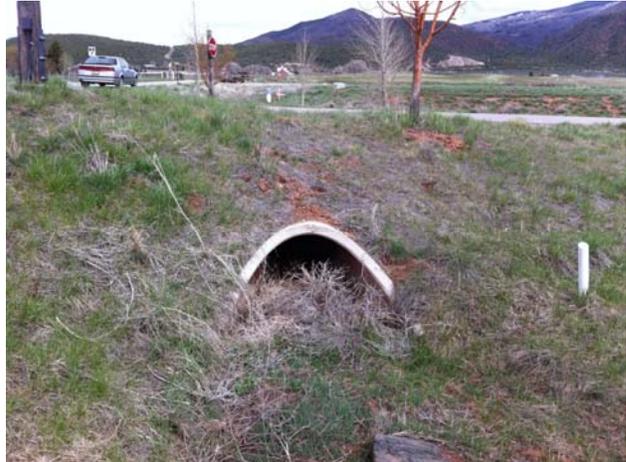
Culvert under Foxprowl.

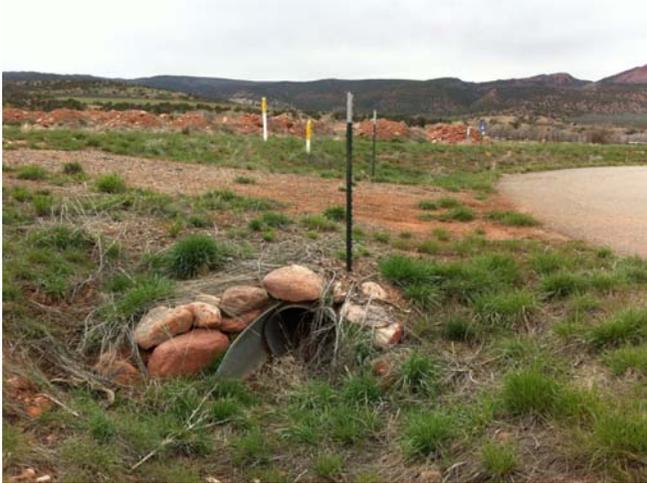
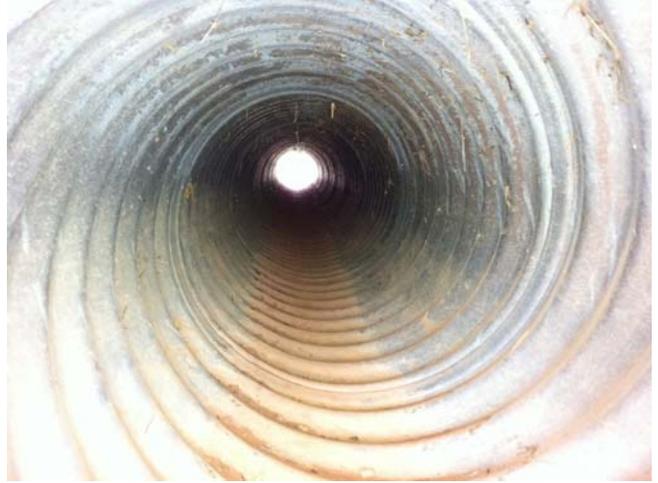
There are a few corrugated metal pipes (CMP's) installed at Brightwater. A total of six, 12" diameter CMP's are installed, two each at the cul-de-sac's on Cutbow, Herons Way and Bucktail. These pipes were installed to provide vehicular access north and south from the cul-de-sac across the roadside ditch. These pipes appeared free of damage and were also free of sediment. A seventh CMP is installed at the north end of Hare's Ear and appears in reasonable condition with only minor siltation.

CMP on the south side of Heron’s Way cul-de-sac. CMP on the south side of Heron’s Way cul-de-sac.

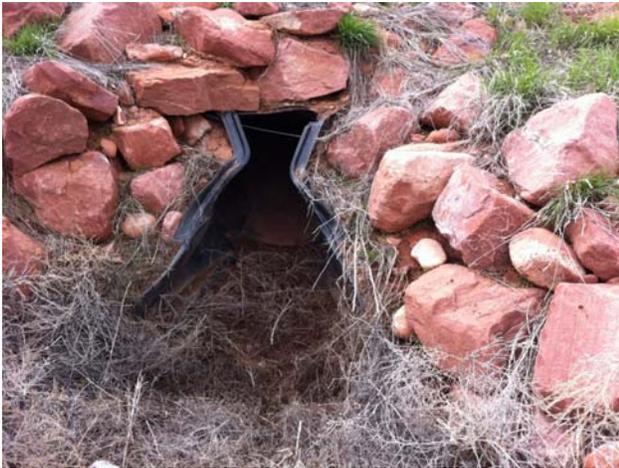
There are two high density polyethylene (HDPE) pipes that were observed onsite. One is under the start of the access to fishing cabin off the west end of Cutbow Lane. It appeared to be in good condition, with minor siltation and no end sections. The second HDPE pipe is a 36” diameter pipe, approximately 160’ long, running under Brightwater Club Drive between Bucktail and Herons Way. The end section at the inlet of this pipe has been partially collapsed by the surrounding rocks. The inlet end of the pipe has some siltation. There is a small belly in the pipe nearer to the outlet end, as well as a depression in the top of the pipe.

Inlet end section of 36” HDPE pipe.

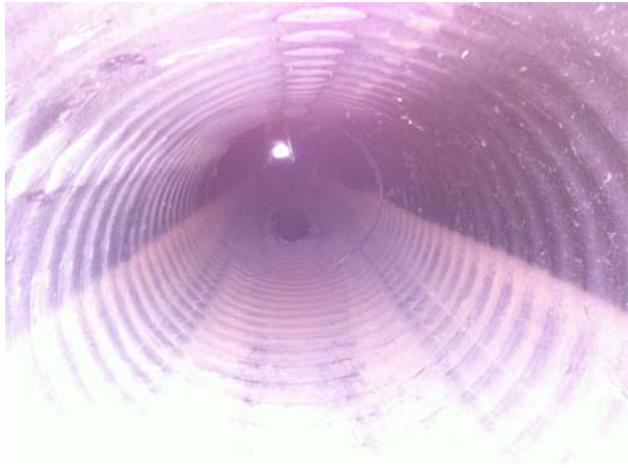
Small belly in the 36” HDPE pipe.
